TECHNICAL REPORT CERC-90-7

KING HARBOR, REDONDO BEACH, CALIFORNIA, BREAKWATER STABILITY STUDY

Hydraulic Model Investigation

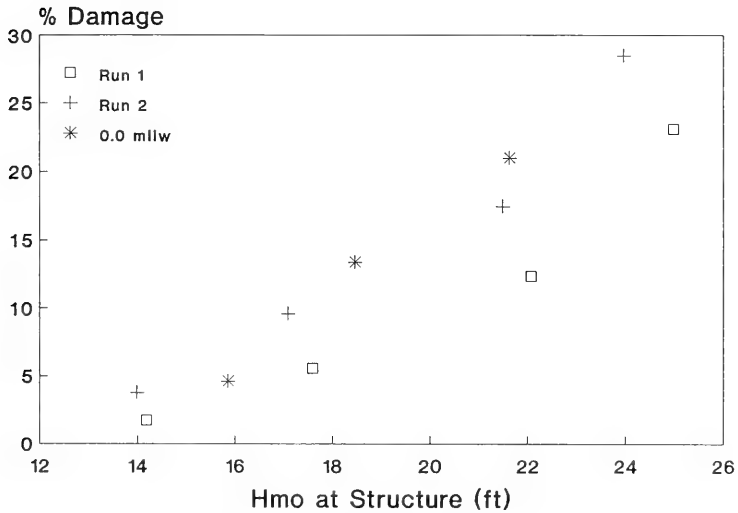
Figure 14. Sea-side damage, Plan 3

32. Plan 3 was subjected to the 12 design waves at +7.0 ft mllw and repeated. During the repeat test, the regular series of test waves for a constant wave height was conducted at a swl of +7 ft mllw, and the damage was assessed; then the water level was dropped to 0.0 ft mllw and that constant wave height repeated for a 16-sec wave period (see Table 1) and damage assessed again. Wave action at the low water contributed to the overall damage on the sea side (Figure 14) but did not cause significant instability of

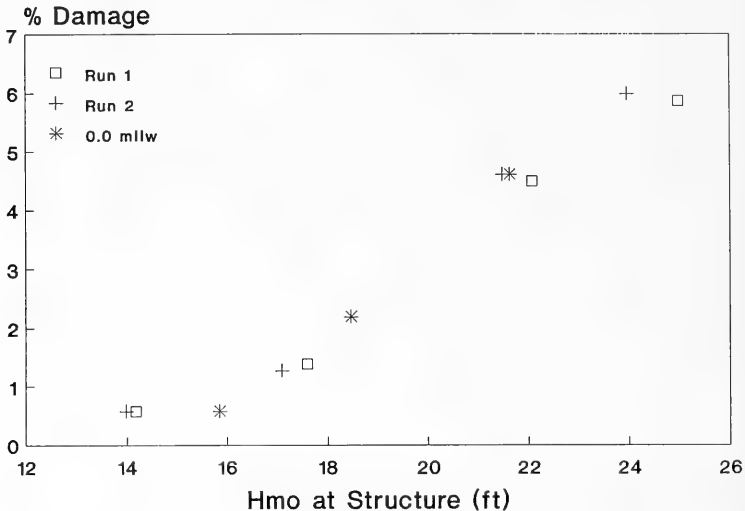
Figure 15. Harbor-side damage, Plan 3

the toe stone. Damage to the harbor side, including damage caused by waves at low water, is shown in Figure 15. Waves generated at low water caused little damage to the harbor side. The harbor-side section was not damaged for $(H_{mo})_i \leq 18$ ft, and maximum damage was approximately 6 percent.

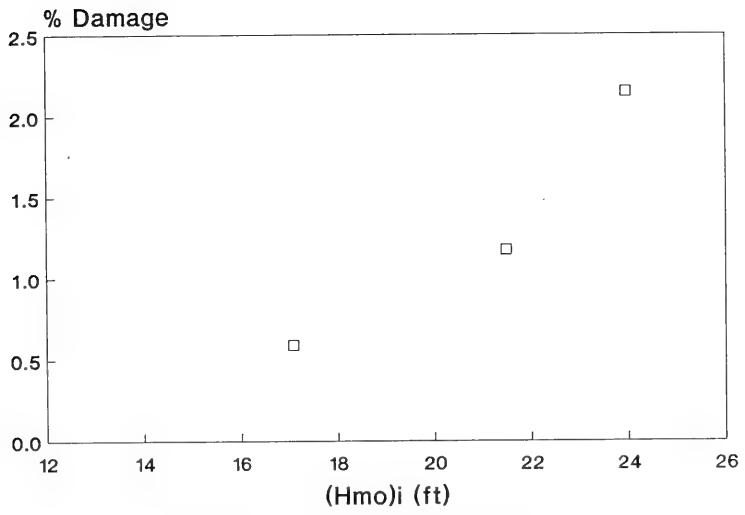
Figure 17. Zone 2 damage, Plan 3

33. Plan 3 consisted of only one rehabilitation section covering the harbor side; therefore, some stones near the crest which roll onto a lower part of the rehabilitation section are not counted as displaced stones. Because Plan 2 gave an indication of the crest stability, it was desirable to separate Plan 3 into sections to determine the performance of smaller armor units placed at the crest. To compare Plan 3 with Plan 2, the harbor-side section was divided into two zones, and the number of armor units displaced from each zone was recorded during the repeat test of Plan 3. Zones 1 and 2 were defined as the rehabilitation sections from the seaward end of the crown to +10 ft mllw, and from +10 to -10 ft mllw, respectively. Figure 16 shows percent damage to Zone 1 versus $(H_{mo})_i$. Damage to Zone 1 was 10 percent or less for $(H_{mo})_i < 22$ ft, but for the 24-ft wave, damage was 63 percent. The increase in damage is a result of heavy overtopping of the structure. Damage to Zone 2 was minor for the 24-ft wave and not damaged for lower waves (Figure 17).

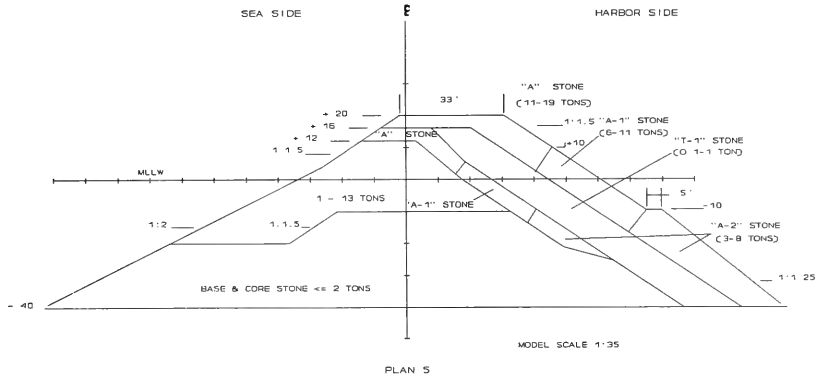
Figure 22. Plan 5, King Harbor stability study

41. Plan 5 (Figure 22, Photos 19-33) was similar to Plan 4 but consisted of a 10-ft-thick transition layer of 200- to 2,000-lb stone ("T-1" Stone). The armor layers on the harbor side were the same as in Plan 4.

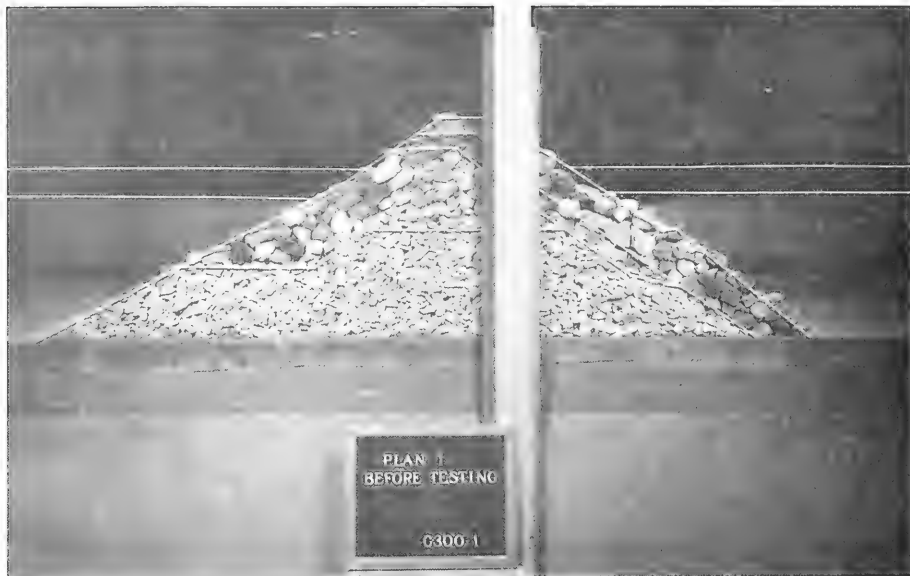
Photo 1. Plan 1, before testing, side view

23. Plan 1 (Figure 4, Photos 1-6), proposed by SPL, consisted of raising the crest elevation to +20 ft mllw by adding one layer of 11- to 19-ton stone ("A" Stone) to the existing crest, adding two layers of "A" Stone to the harbor side slope from -10 ft mllw to the crest, and placing 3- to 8-ton stone ("A-2" Stone) to -10 ft mllw from the base of the breakwater on the harbor side to form a toe buttress. Placement of armor units on the harbor side at King Harbor is more economical because shallower water depths result in less armor stone required and armor stone placement by ocean-borne construction equipment is protected by the breakwater.

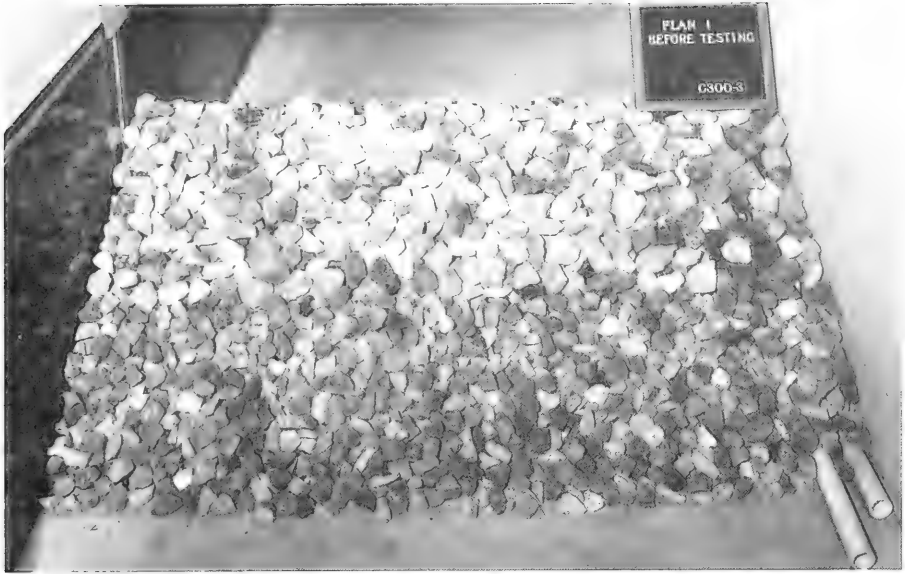
Photo 3. Plan 1, before testing, harbor-side view

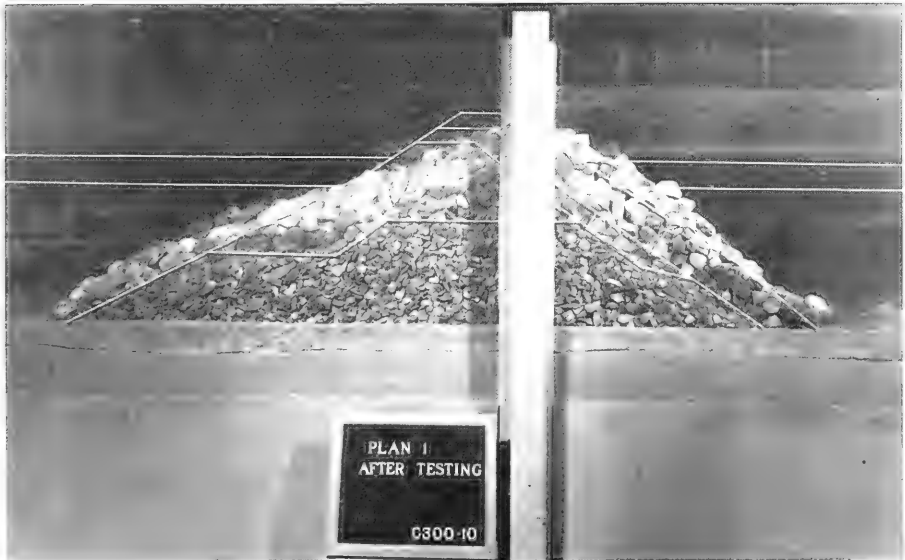
Photo 4. Plan 1, after testing, side view

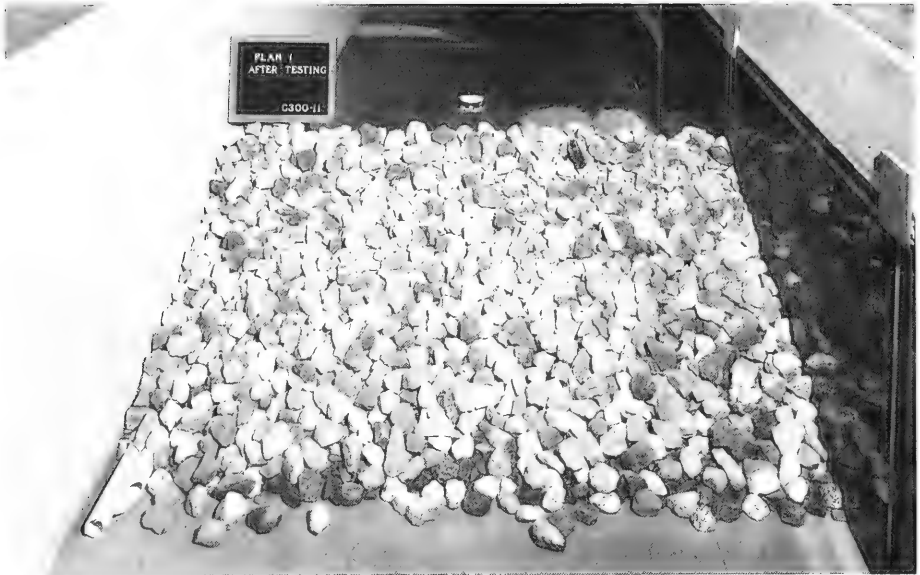
Photo 5. Plan 1, after testing, sea-side view

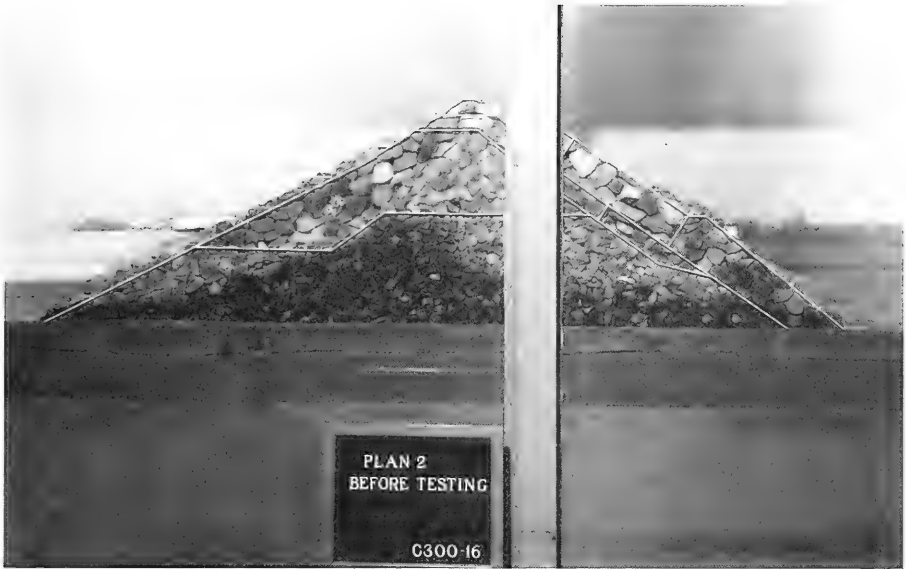
Photo 7. Plan 2, before testing, side view

27. Plan 2 consisted of the same geometric cross section as Plan 1, but 6- to 11-ton armor stone ("A-1" Stone) was placed from +10 ft mllw to -10 ft mllw, with "A" Stone placed from +10 ft mllw to the crown on the harbor side (Figure 8, Photos 7-12). "A-1" Stone was chosen by SPL as the most economical armor size to replace the larger armor units. The toe buttress was composed of "A-2" Stone, identical to Plan 1.

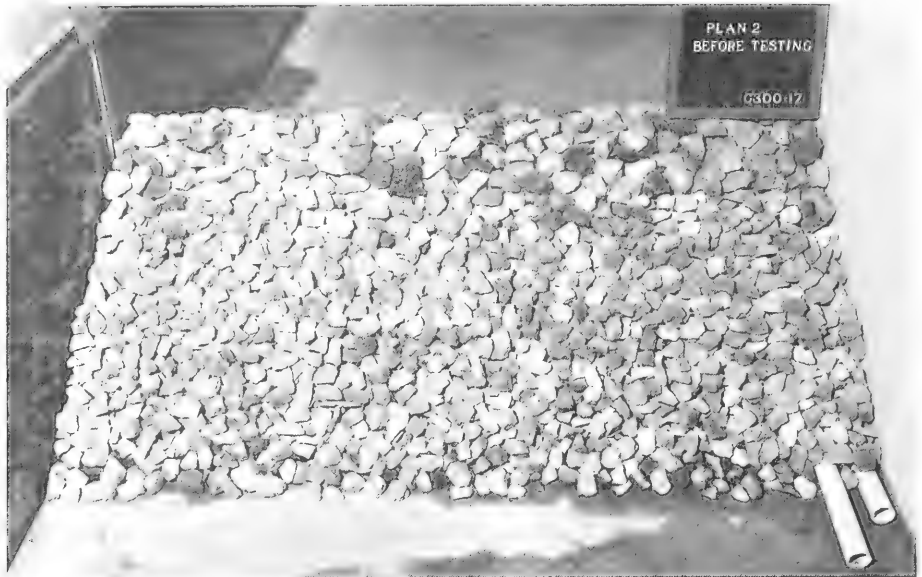
Photo 9. Plan 2, before testing, harbor-side view

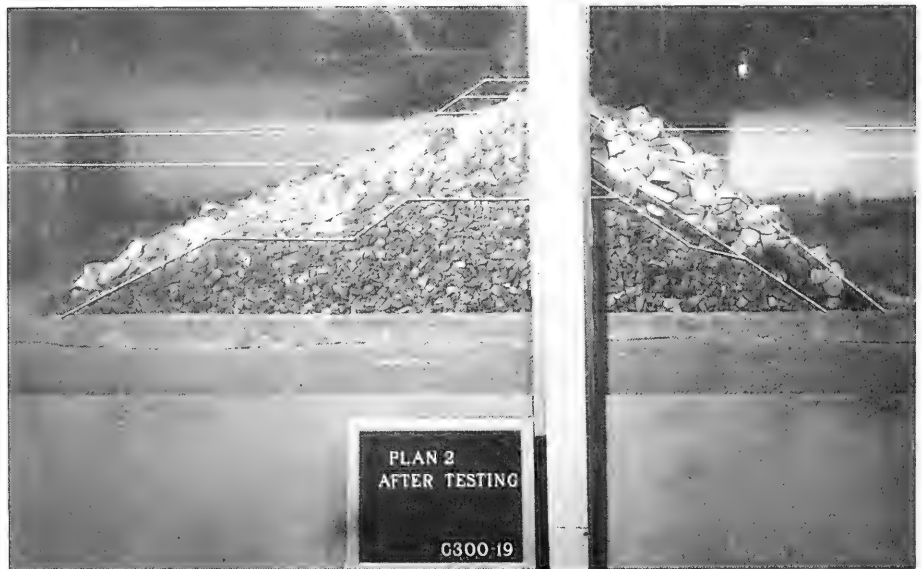
Photo 10. Plan 2, after testing, side view

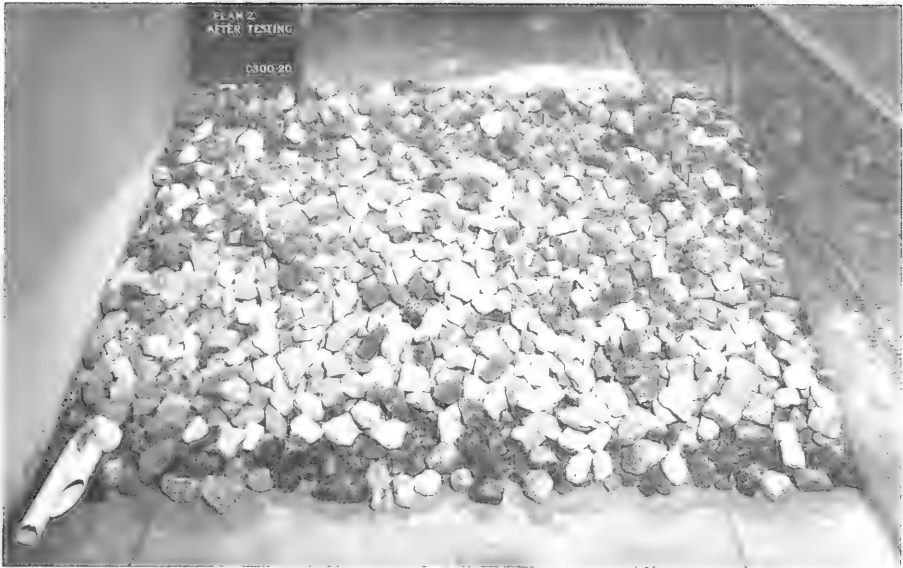
Photo 11. Plan 2, after testing, sea-side view

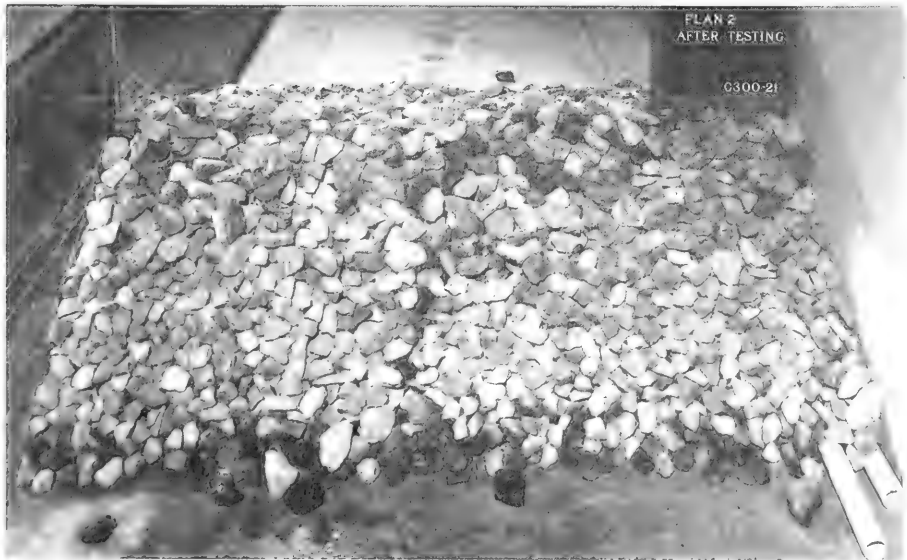
Photo 12. Plan 2, after testing, harbor-side view

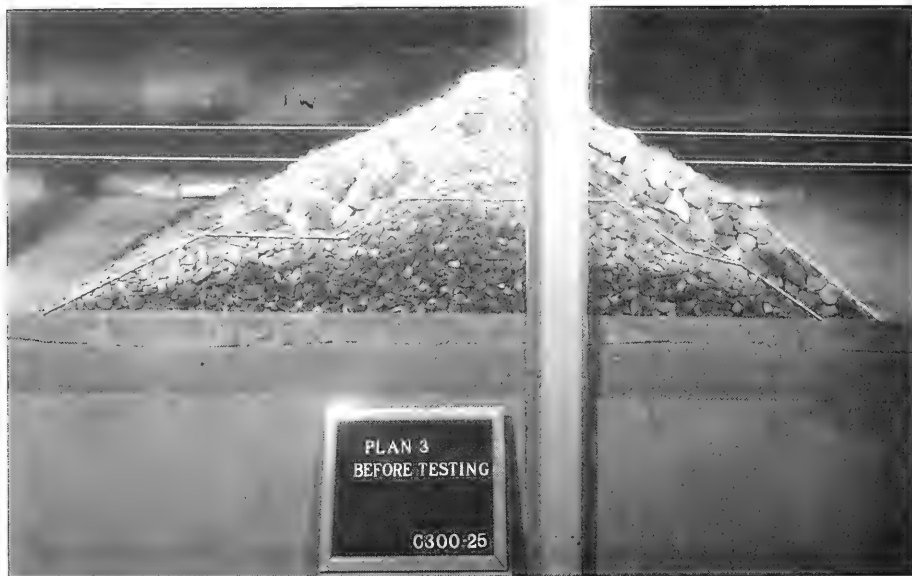
Photo 13. Plan 3, before testing, side view

31. Results from Plan 2 indicated that the "A-1" Stone was stable for all waves if placed on the middle section of the harbor side; "A" Stone in the upper section was stable for $(H_{mo})_i < 22$ ft ; and stability tests with smaller armor stone placed in the upper section might be stable. Plan 3 (Figure 13, Photos 13-18) consisted of the same geometry as Plan 1, except "A-1" Stone was placed on the harbor-side slope from the breakwater crest to -10 ft mllw. The harbor-side toe buttress remained the same as previous plans.

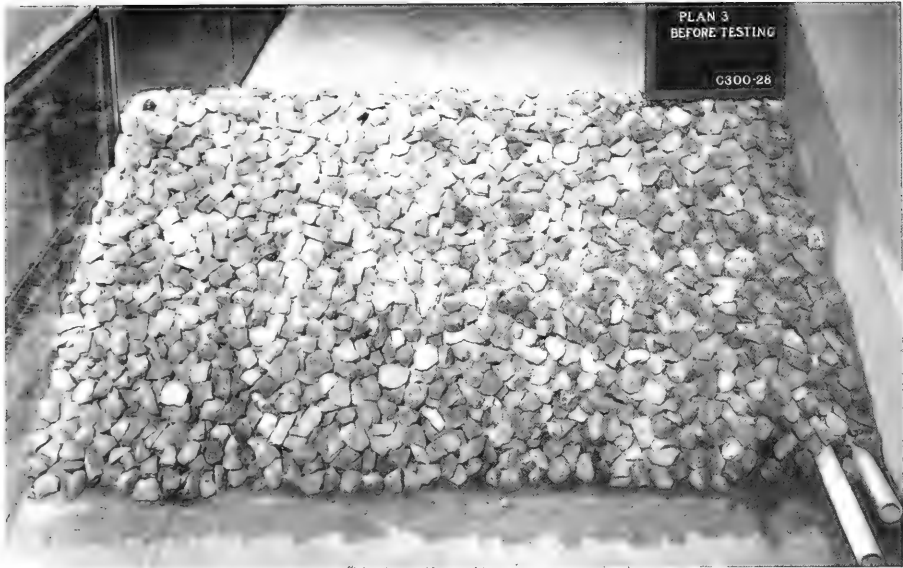
Photo 15. Plan 3, before testing, harbor-side view

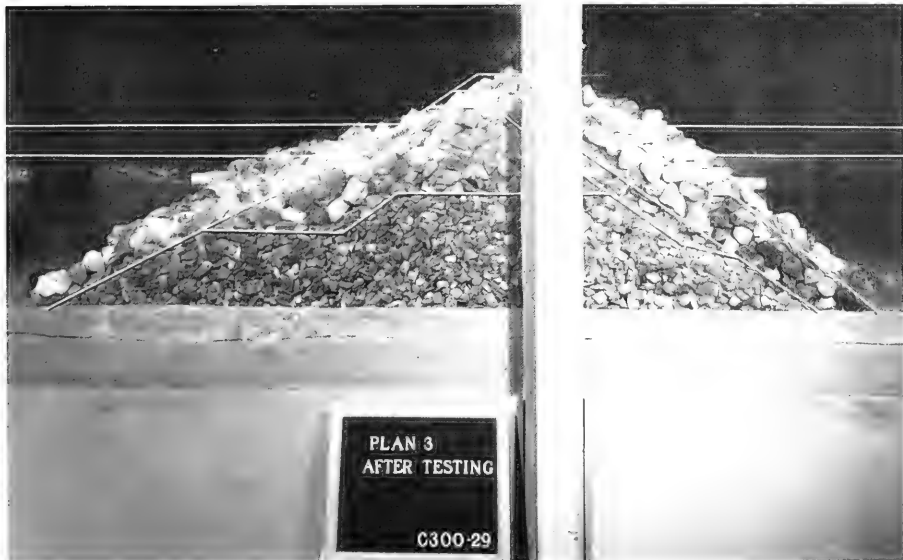
Photo 16. Plan 3, after testing, side view
